Overview The visual inspection of synthetic ropes before use is critical in most industrial applications. The residual strength of a rope, the prime indicator of its useful and safe remaining working life, must be assessed before committing the rope to continued use. With high-performance synthetics like HMPE replacing steel-wire ropes in many applications, the need for a method to determine the state of a rope is more critical than ever before. The problem is that there is no common, standardized language or reference scale to describe the state of a rope. To date, judgment on the state of the rope has required a synthetic rope expert to complete an inspection on-site. The alternative is removing the rope from service and testing the rope to destruction in order to evaluate residual strength.

The Abrasion Comparator

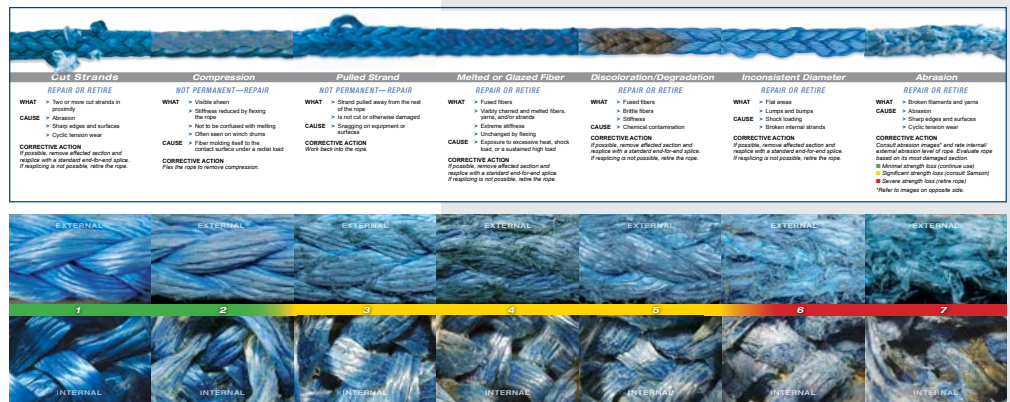
The Pocket Guide includes information on proper rope inspection techniques and corrective action steps.

The resulting guide provides a means of estimating the state of the rope and whether it should be repaired or retired from use. The Inspection and Retirement Checklist section of the Guide describes the seven common forms of damage: cut strands, compression, pulled strands, melted or glazed fiber, discoloration/degradation, inconsistent diameter, and abrasion. It provides a visual reference for each and a determination of the cause and possible corrective action that can be taken.

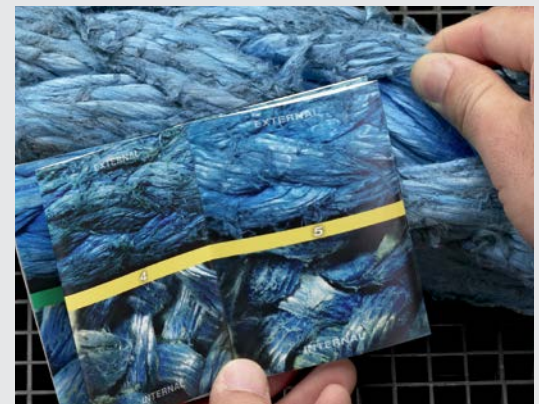
The comparator is an easy reference that can be used in the field to help assess the state of a rope. Small and easily held in the hand while performing an inspection, it helps establish a guideline and a common language when discussing the state of a rope.

The Abrasion Comparator shows a 12-strand HMPE rope—*AmSteel® Blue*—in a range of abrasion states from new rope to rope ready for retirement. The images represent a scale numbered from 1 through 7 that ranges from minimal strength loss (steps 1 and 2), significant strength loss (steps 3 through 5), to severe strength loss (steps 6 and 7). Each is further tagged with an action—for ropes with significant strength loss, consult Samson; for severe strength loss, retire the rope. Images are provided for both external abrasion and internal abrasion. When consulting your Samson dealer or representative you now have a ready reference to accurately describe the state of the rope in question.

The comparator is an easy reference that can be used in the field to help assess the state of a rope. Small and easily held in the hand while performing an inspection, it helps establish a guideline and a common language when discussing the state of a rope. It is printed on extremely durable synthetic paper that is resistant to tearing and comes packaged in a vinyl sleeve to make it 'pocket friendly.'
